Figure MS-2 Problem Areas - Main Stem Subwatershed

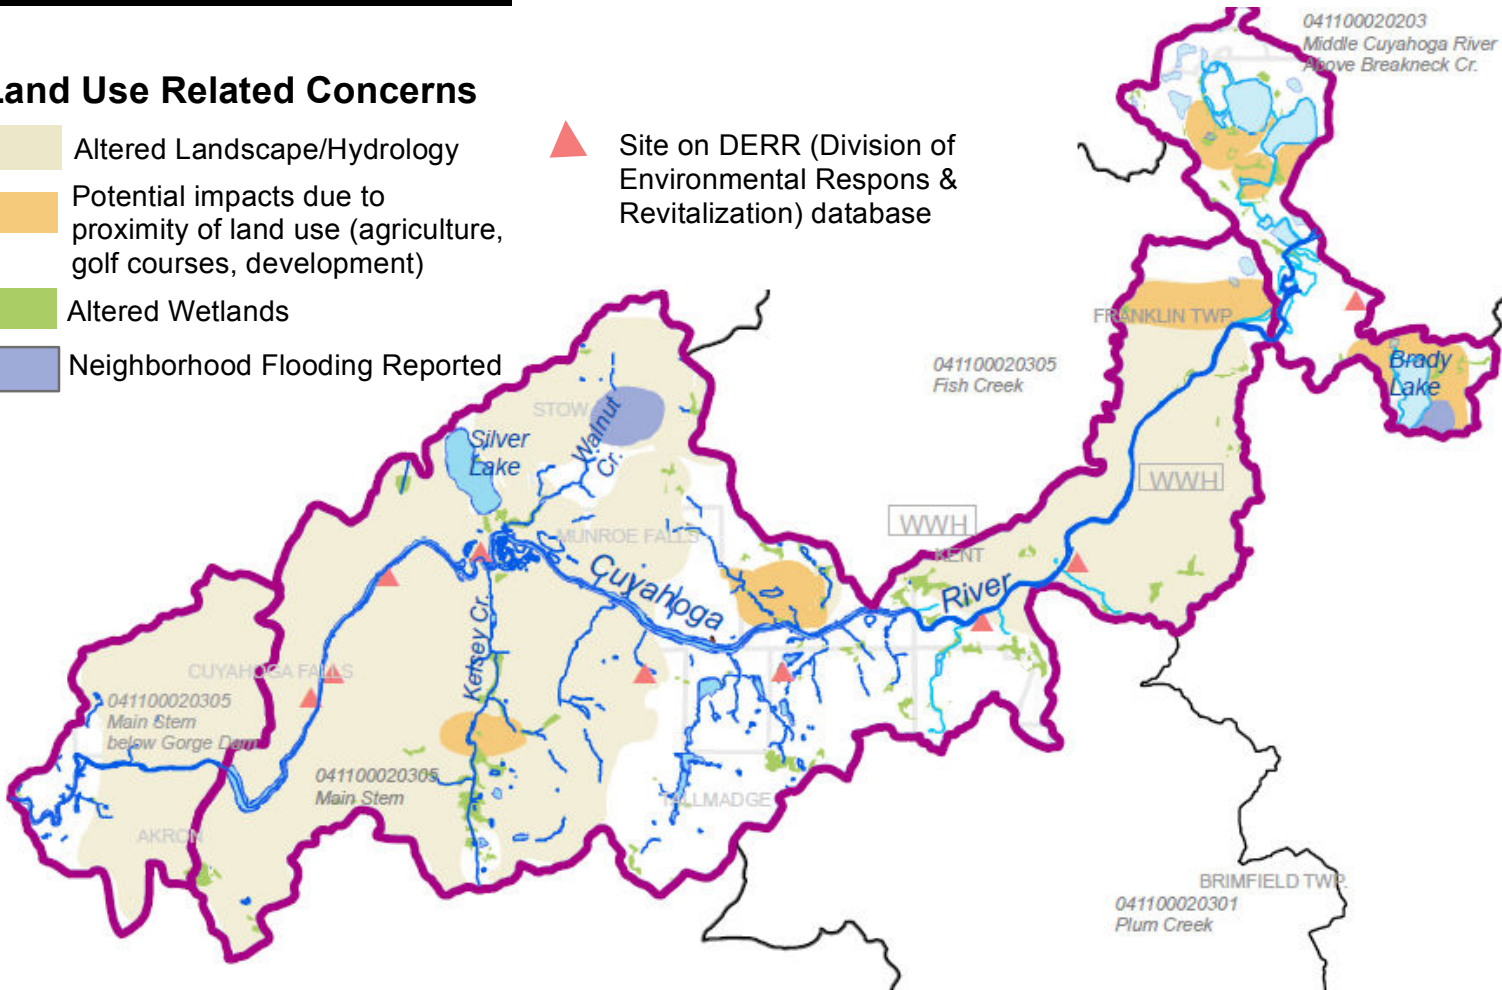
Land Use Related Concerns

- Altered Landscape/Hydrology
- Potential impacts due to proximity of land use (agriculture, golf courses, development)
- Altered Wetlands
- Neighborhood Flooding Reported
- ▲ Site on DERR (Division of Environmental Respos & Revitalization) database

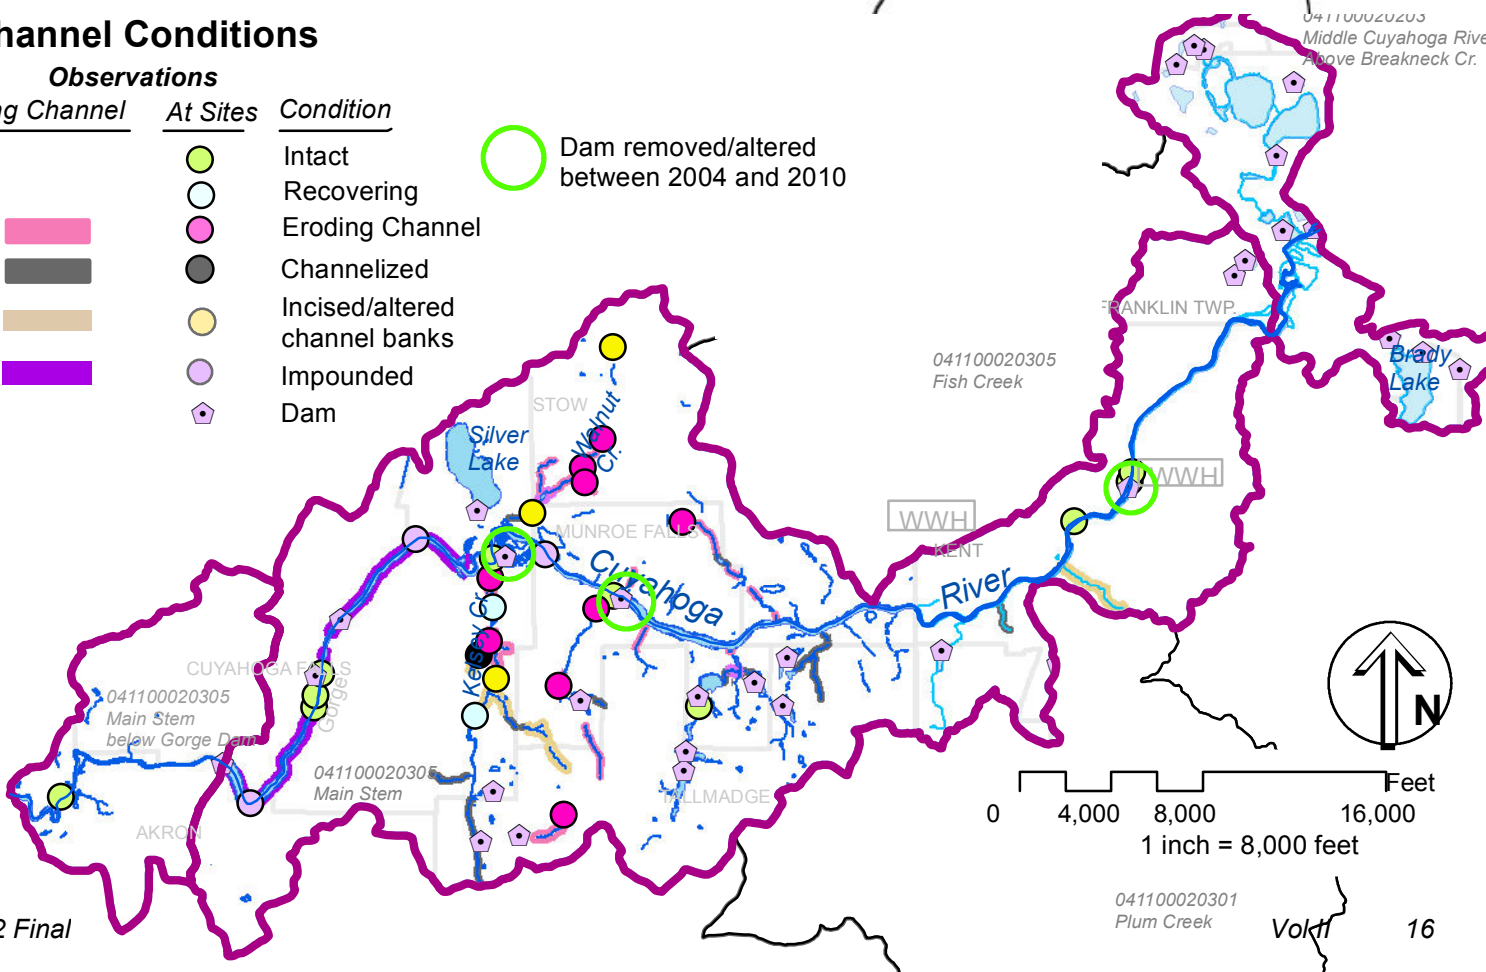
Channel Conditions

Observations

Along Channel	At Sites	Condition
		Intact
		Recovering
		Eroding Channel
		Channelized
		Incised/alterned channel banks
		Impounded
		Dam

Dam removed/alterned between 2004 and 2010
